## Prestigious Local College - Balcony

Surface Repairs and Rectification

Slip Resistant Surfacing System, Low Maintenance

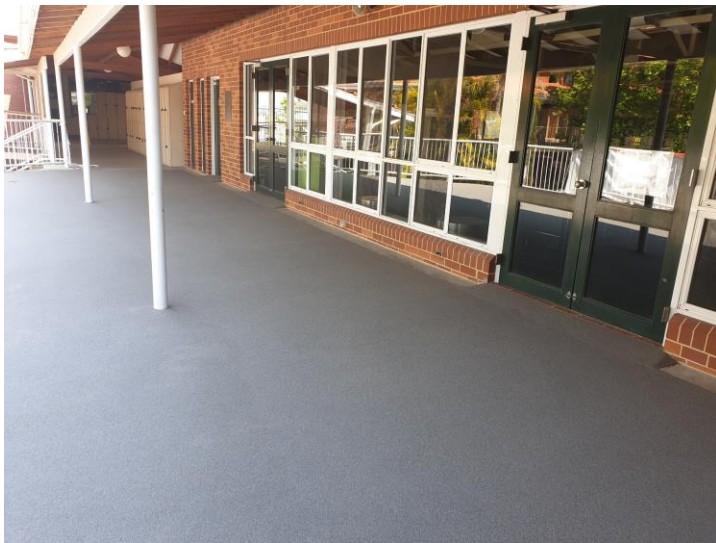
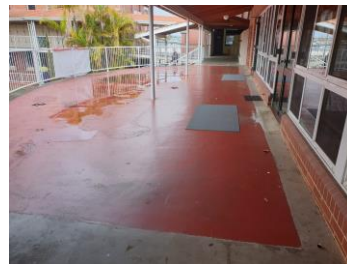
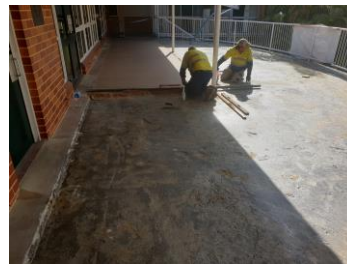
**Project Brief:** The 1<sup>st</sup> Floor balcony outside the Library at this prestigious local college was badly failing and dangerous due to poor drainage. It was also unsightly and a slip hazard. Antiskid were engaged to provide an appropriate solution which needed to be aesthetically pleasing, long lasting, easily maintainable and providing long term slip resistant qualities. The window for works was necessarily short due to the constant requirement for access via the balcony. Another issue was the location close to rooms that were utilised for senior examinations over school holidays.

**Solution:** Due to the uncertain history of previous works it was recommended to remove the entire failing substrate to determine the extent of any underlying issues. The Antiskid team did this working around noise restrictions to minimise disruption. The team had to remove 3 layers of previous repair attempts. They then installed Leveltop decking to

build-up the area and create falls to drains to ensure correct levels and function. The surface was then ground down to create an appropriate bond surface and was primed prior to the application of Omnigrip Deco in the client approved colour. The final step was the application of a Polyurethane sealer to provide Ultra-Violet resistance as well as assisting with ongoing maintenance and cleanliness. An outstanding result for all concerned with long term beauty and minimal disruption.
