Pan Pacific Hotel – Loading Dock

Concrete Repairs and Rectification

Slip and Impact Resistant Surfacing System

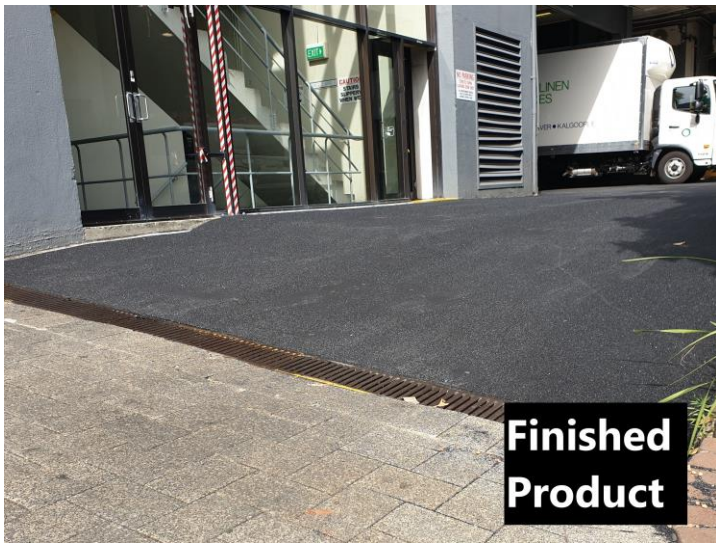
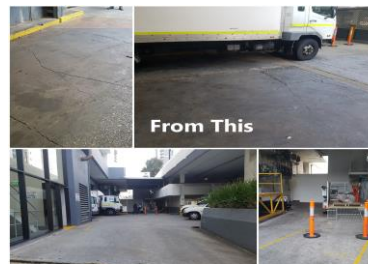
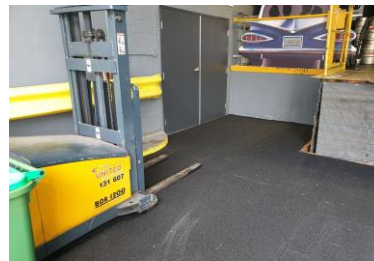
Project Brief: The loading dock at Pan Pacific was in sub-par condition and was becoming hazardous for all users including guests crossing over from the car park. It was an old concrete dock that encompassed the staff entry, the service and bin storage as well as the goods lift and double truck bays. Therefore, the surface needed to be extremely tough as well as slip, impact & UV resistant while still being aesthetically pleasing and pleasant for pedestrians. The major problem though, was that this loading dock was in constant use for all the requirements of a superior CBD hotel. It could not be shut down. **Solution:** Antiskid were tasked with resolving this problem and our designers suggested Omnigrip CST Black Gloss. This is a very hard-wearing surface that is consistent with an asphalt design but has additional benefits over standard asphalt. It can be

applied over existing concrete and has very good crack bridging properties. Antiskid staff firstly performed concrete repairs to the underlying substrate before the application of the Omnigrip. Works were completed in consultation with the client over two weekends to ensure continuity of service and a minimum of disruption. The result is spectacular and will service the clients needs for many years to come with minimal maintenance required.
