Pan Pacific Perth - 9th Floor Podium Deck

Seamless Waterproofing System
Water Pooling Rectification

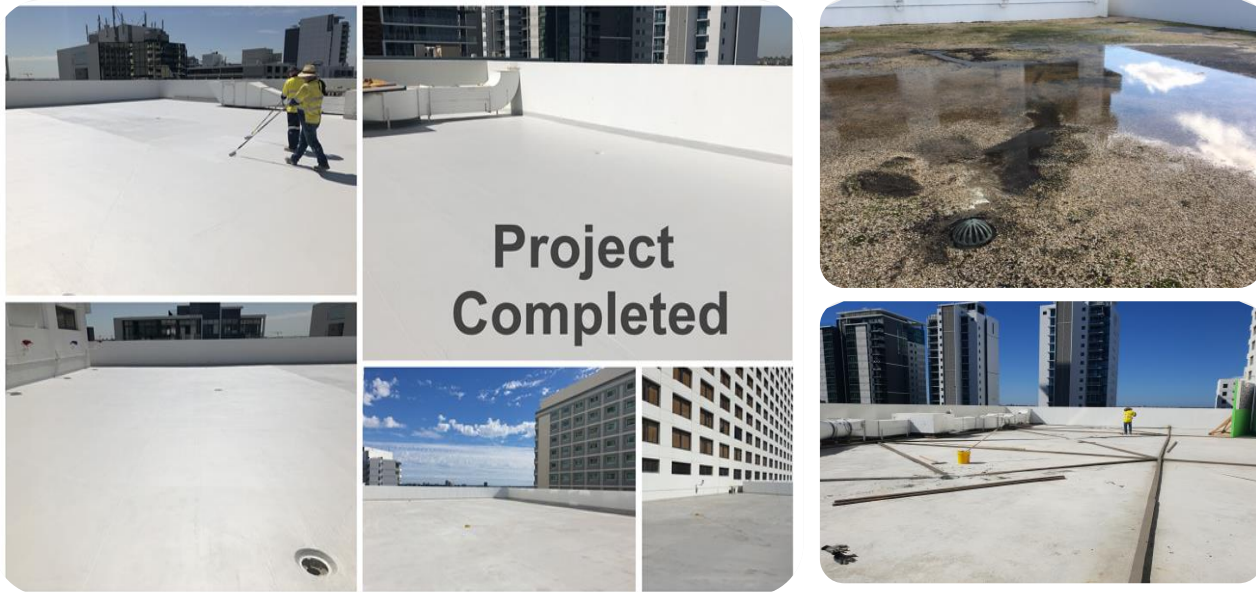
Project Brief: Substantial rainwater ponding had been experienced over a number of years on the 9th Floor Podium Deck of the Pan Pacific Hotel in Perth CBD. This resulted in water seepage into the building proper and potential issues with carbonation and salt penetration. There was also evidence of concrete cracks and some slab deflection. Antiskid Industries were engaged to provide the solution which was a highly technical and complex project and required input and liaison from product manufacturers, consulting engineers and Antiskid's expert staff.

Solution: The first step was removal of the existing membrane system and the white quartz stone topping from the 9th floor whilst the Hotel remained in full operation. Repairs were then performed to all surface cracks, expansion joints and failed penetrations using injectable epoxy resin systems. The next step was rectification of the deflection as well as the ponding by infilling existing low levels of the surface to create correct falls to drains. Antiskid

staff expertly created a backbone arrangement which was then infilled with Sika Level 30 product ready for the seamless waterproofing. The final action was the application of Sikalastic Seamless Waterproofing System incorporating Sika fleece fabric.
